Manhole Inspection Summary

Manhole # S45II_022MH

Insp Date: **4/29/08 3:45 PM**

Location Address: **Gay St**

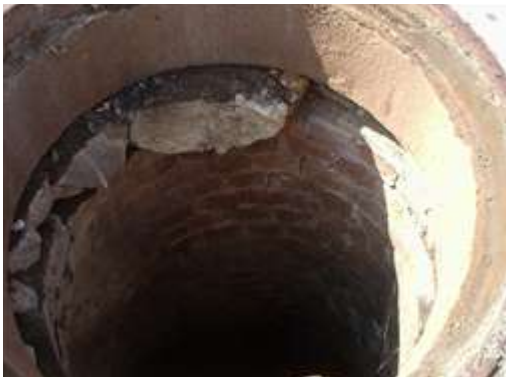
Defect 1

Deterioration

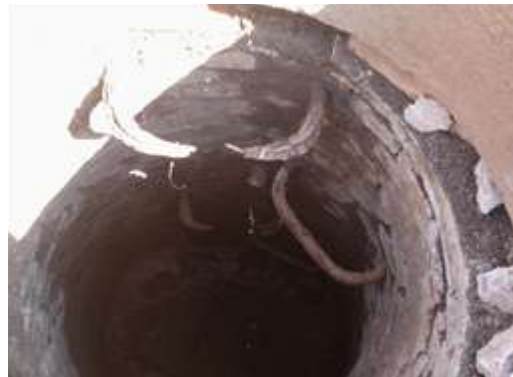
Defect 2

Condition: ☐ Sound ☐ Cracked ☐ Root Intrusion ☒ **Loose Brick** ☐ Deteriorated

Infiltration: ☐ None ☐ Joint ☐ Cracks ☒ **Mortar** ☐ Roots ☐ Wall

Loose Bricks

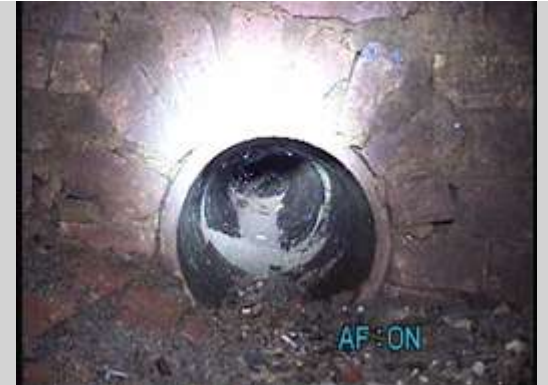
12 O'Clock Outflow

8 in. Circular Gravity Sewer
Pipe Out @ 12 O'Clock

Deposits: ☐ None ☐ Mud ☐ Sludge ☒ **Debris** ☐ Grease

Silt Depth: **1** (in.) Deposits Extent: **Light**
